**ESKIMO V
MAGAZINE SEPARATION TEST**

by
F. H. Weals
and
Bill Finder
Test and Evaluation Directorate

FEBRUARY 1979

**NAVAL WEAPONS CENTER
CHINA LAKE, CALIFORNIA 93555**

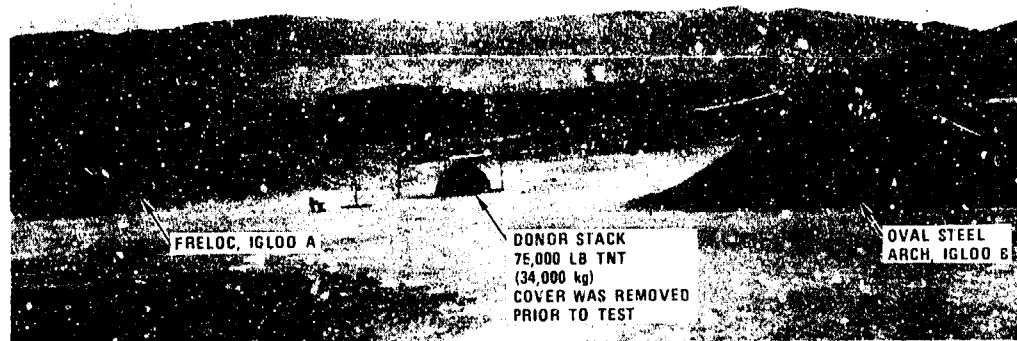
FIGURE 1. Pretest Site Overview.

The ESKIMO V test array consisted of two magazine structures each side-on to the explosion source at centerline separations of 155 feet (47 meters) as shown in Figures 1 and 2. The northwest igloo (Igloo A) was of the FRELOC concrete-arch type constructed especially for this test. The southeast igloo (Igloo B) was the oval steel-arch structure used in ESKIMO II, III, and IV, but modified

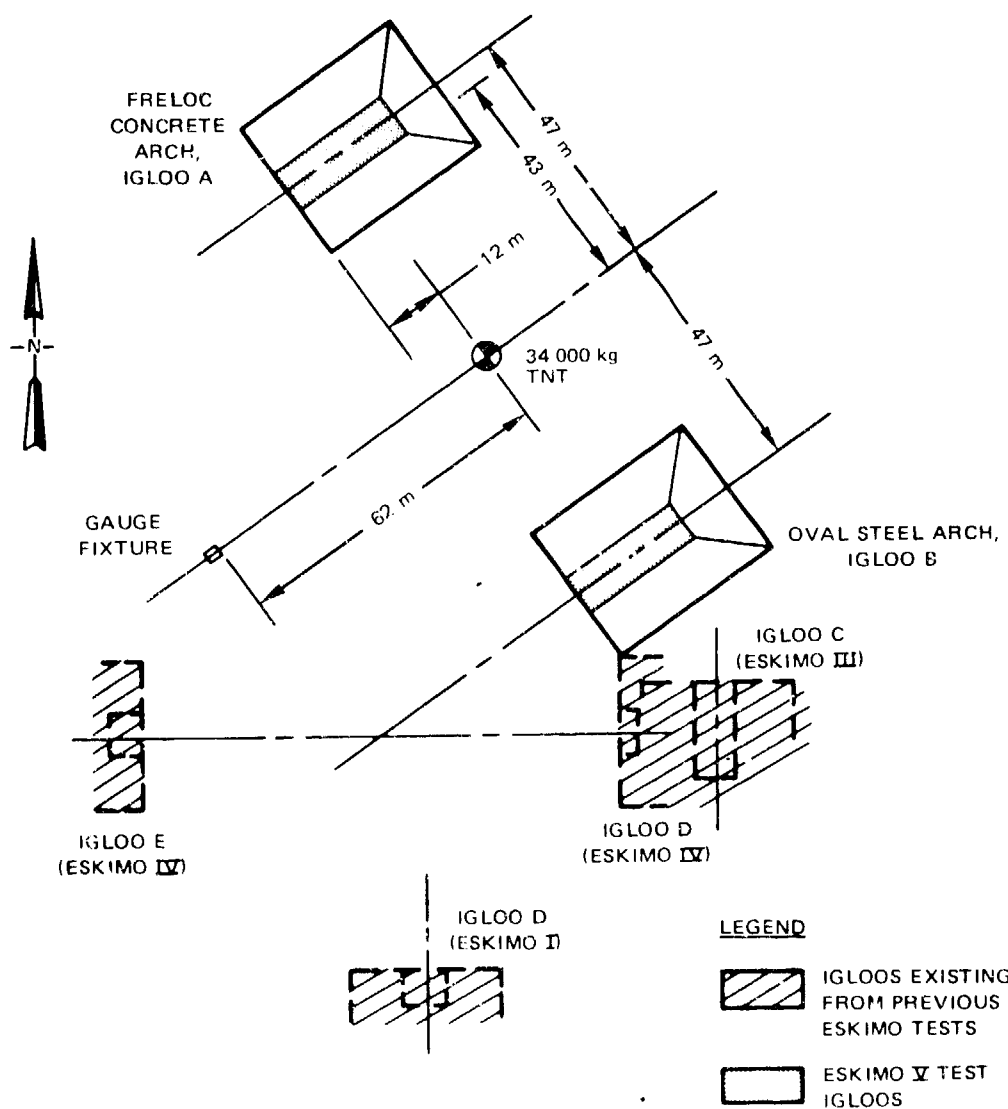
FIGURE 2. ESKIMO V Test Area Layout.

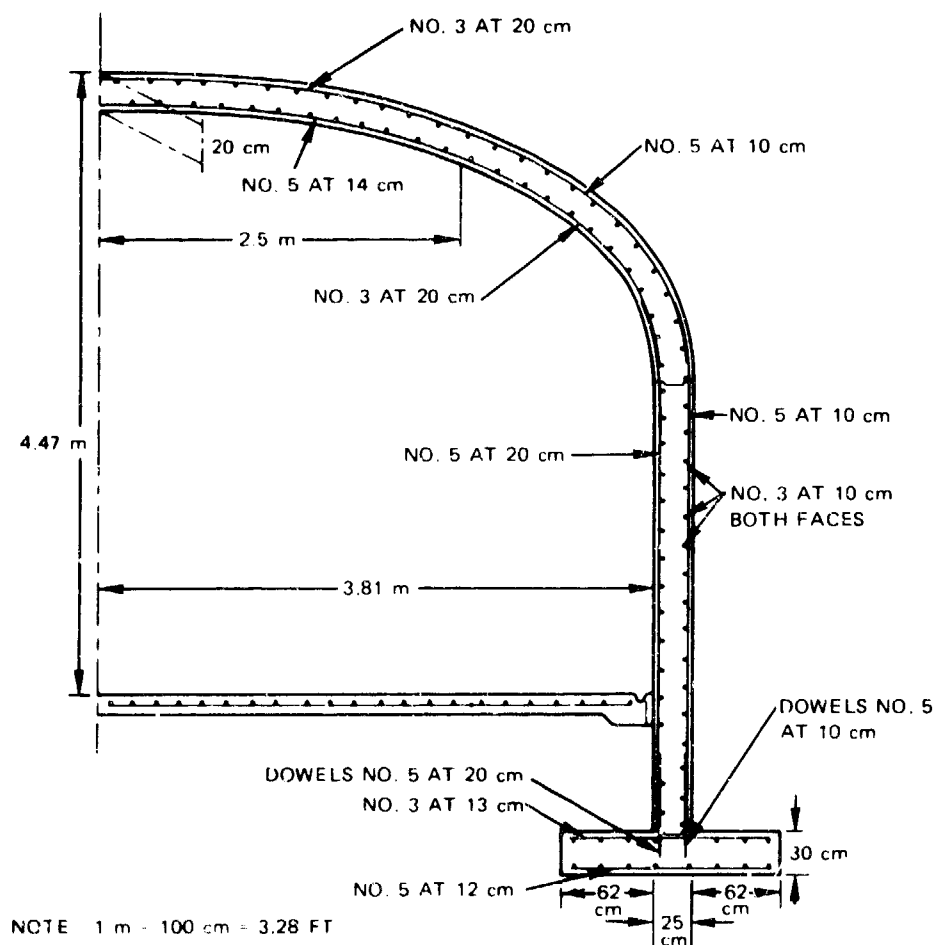
FIGURE 4. Half-Section of FRELCO Igloo Test Structure.

The FRELOC magazine, a noncircular concrete arch magazine, was constructed in accordance with U.S. Army Engineer Command, Europe, Drawing 33-15-13. The magazine, with a nominal span of 26 feet (8 meters), is 80 feet (24 meters) long and has a rise of 14.5 feet (4.4 meters) above the interior floor, which is at the same elevation as the exterior ground surface. The sidewalls are straight and vertical to an elevation of 8 feet (2 meters) above the floor. The arch was covered by 2 feet (0.6 meter) of compacted soil with a horizontal soil layer out to the vertical sides of the arch and then tapered downward at a slope of 2:1 to intersect the original ground level (Figure 4). The concrete pour was completed in five phases:

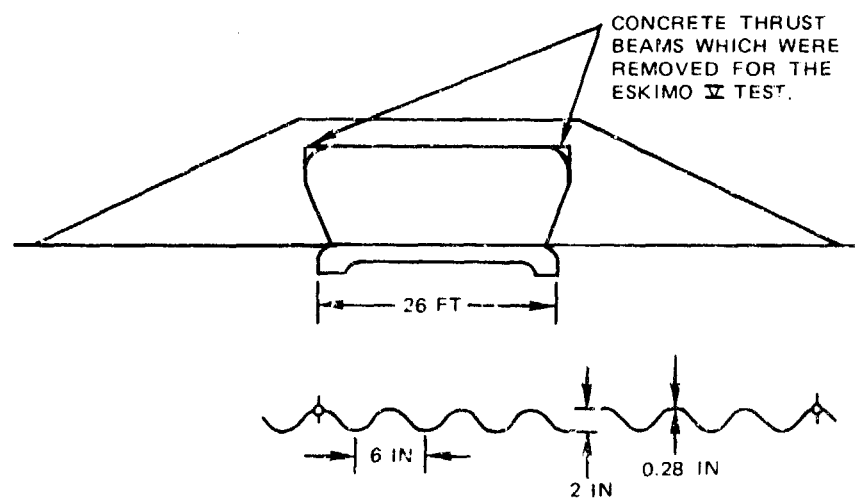
FIGURE 8. Cross Section of Oval Steel-Arch Magazine.

The oval steel-arch magazine was constructed of 1-gauge corrugated steel and had a length of 80 feet (24 meters), a nominal span of 26 feet (8 meters), and a height of 14.5 feet (4.4 meters) from the interior floor to the arch. Figure 8 shows a cross-section of the magazine.

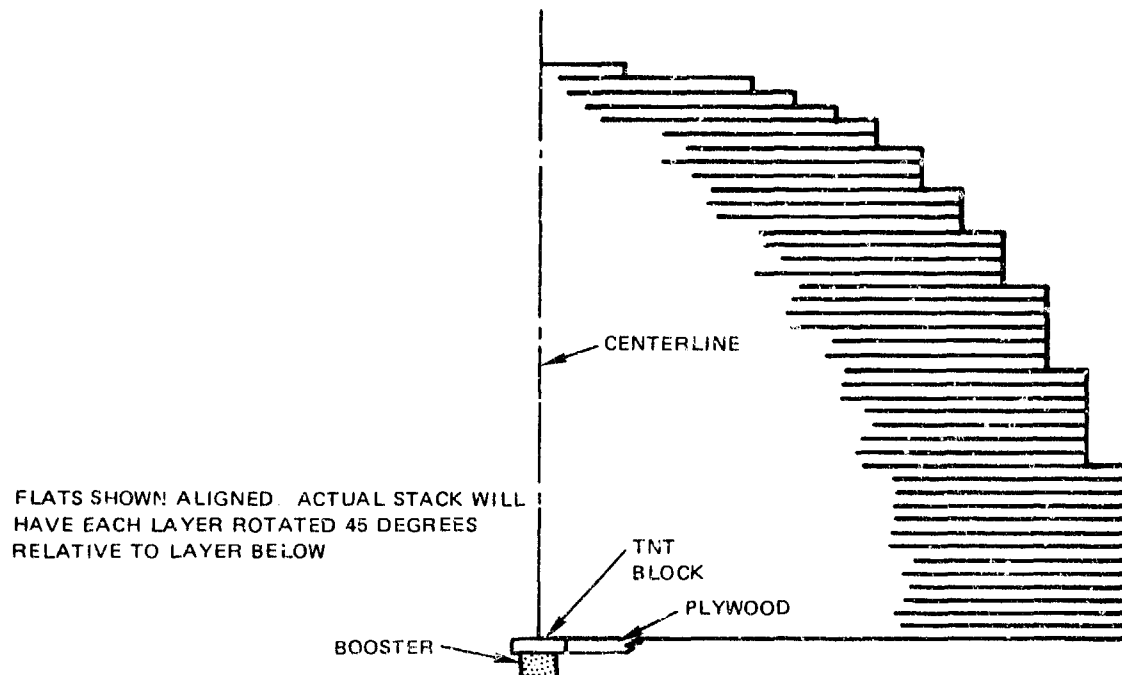
FIGURE 11. Vertical Section of One-Half TNT Donor Stack.

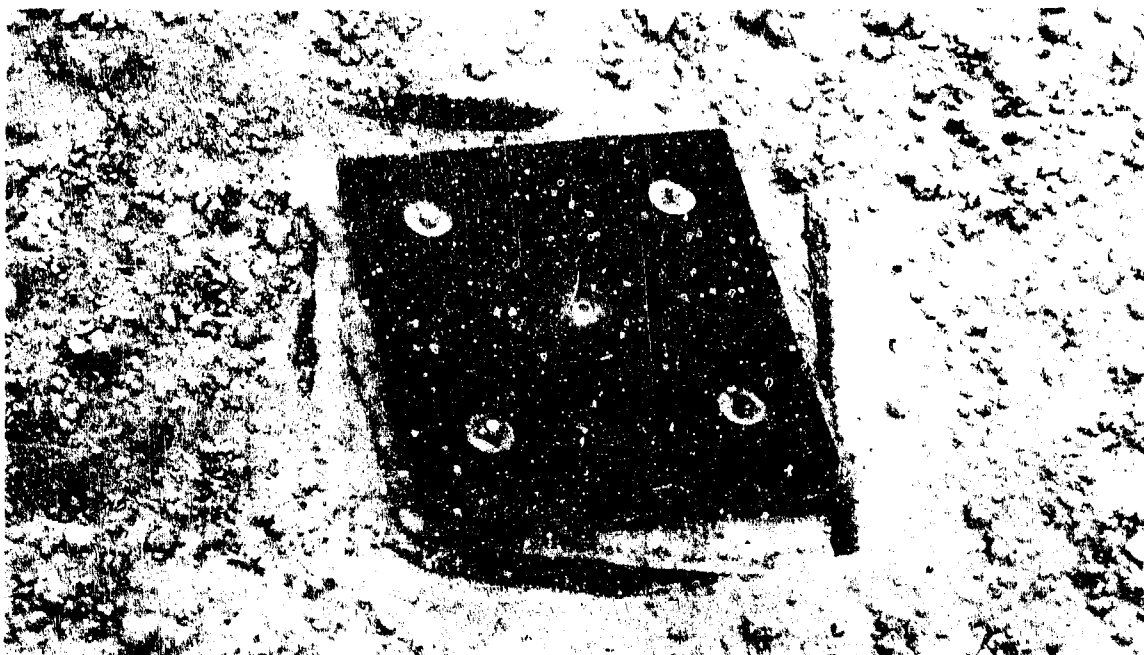
FIGURE 12. Kistler Near-Field Blast Gauge Set into Igloo Earth Cover.

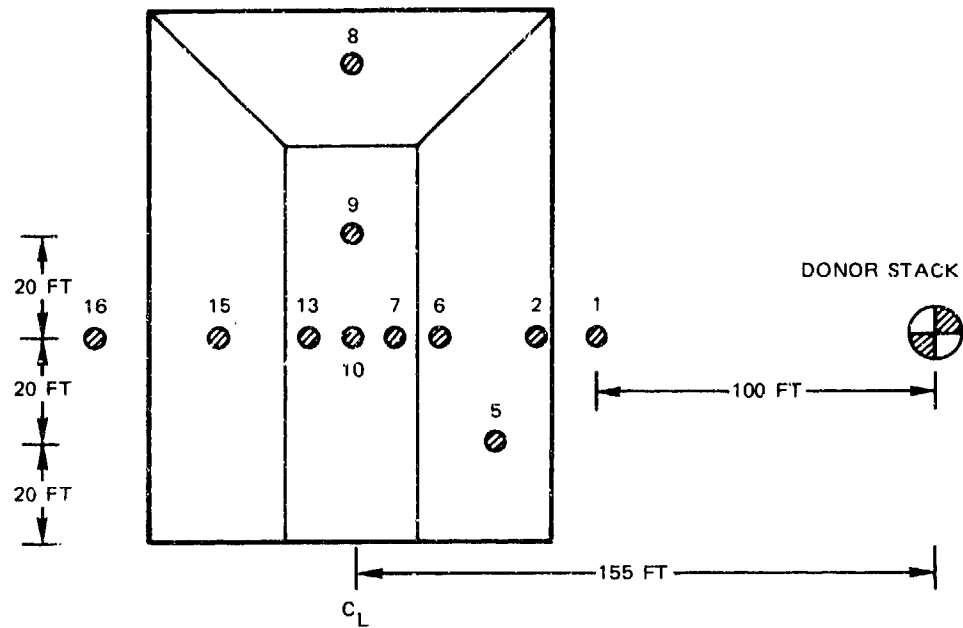
FIGURE 13. Electronic Blast Gauge Layout on FRELOC Igloo.

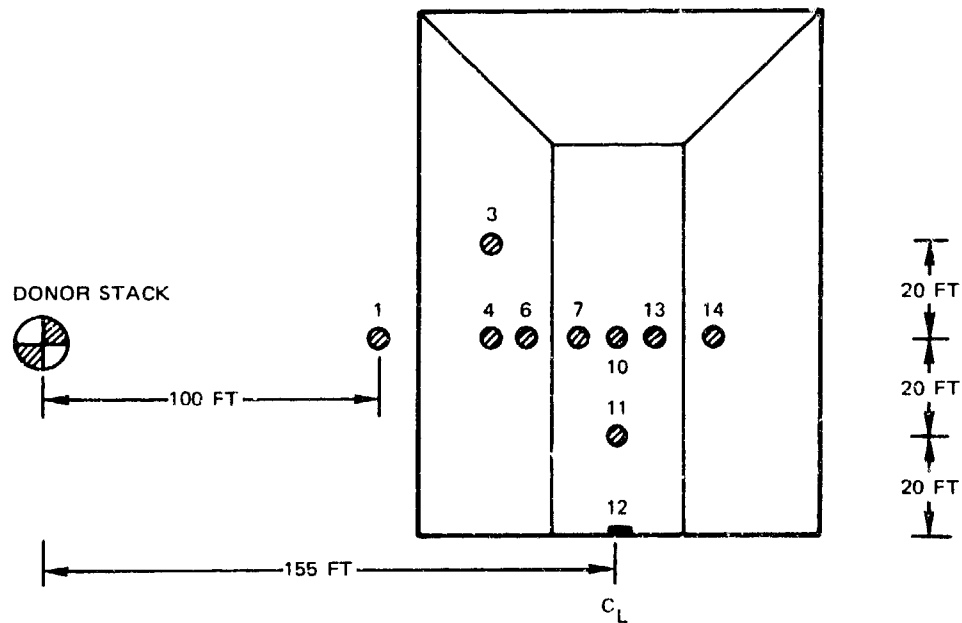
FIGURE 14. Electronic Blast Gauge Layout on Oval Steel-Arch Igloo.

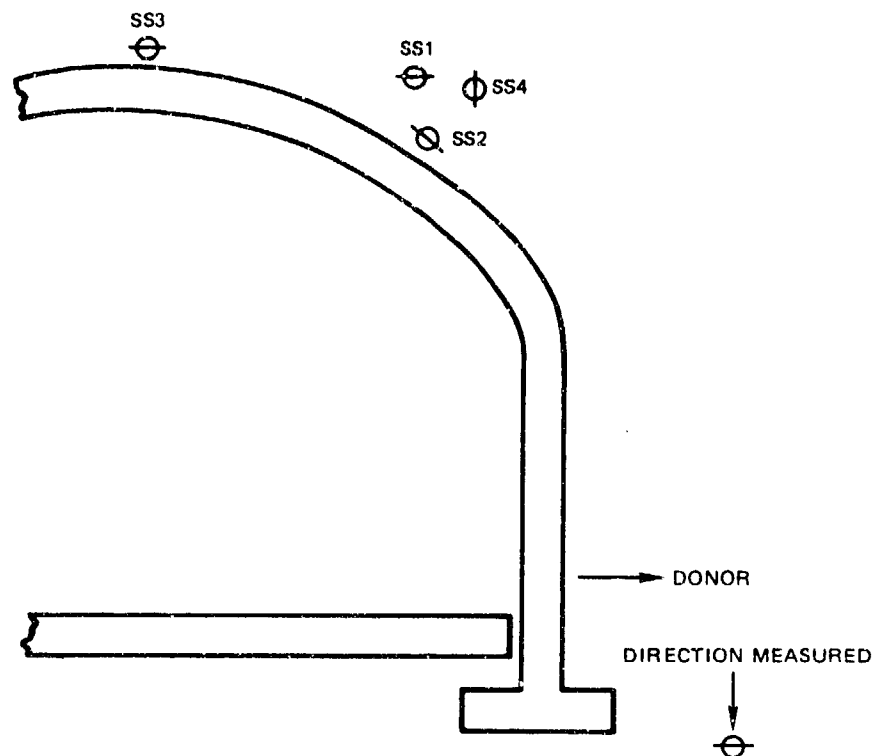
FIGURE 15 Soil Stress Gauge Locations, FRELOC Igloo.

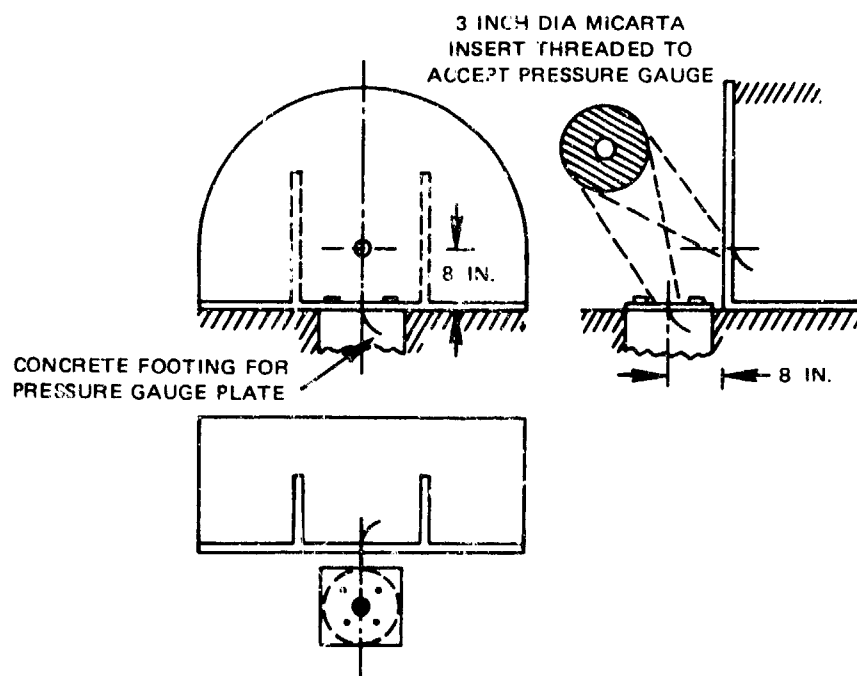
FIGURE 16. Gauge Fixture for Incident and Reflected Pressure Measurements.

The special gauge fixture with the two Byirex blast gauges was to measure reflected overpressure and incident overpressure, but because of the adverse weather conditions water apparently entered the gauge meant to measure incident overpressure and rendered that gauge inoperative. (See Figure 2 for the location of that gauge fixture.) The Kistler-type piezoelectric blast gauges were placed on and around the berm covering of each magazine. Tables 3 and 4 provide a summary of the near-field, blast-gauge data for the FRELOC and oval steel-arch magazines, respectively. Figures 39 and 40 provide a comparison between near-field overpressure and near-field impulse, versus the derived standard curve for a 75,000-pound (34 000-kilogram) hemispherical donor stack.

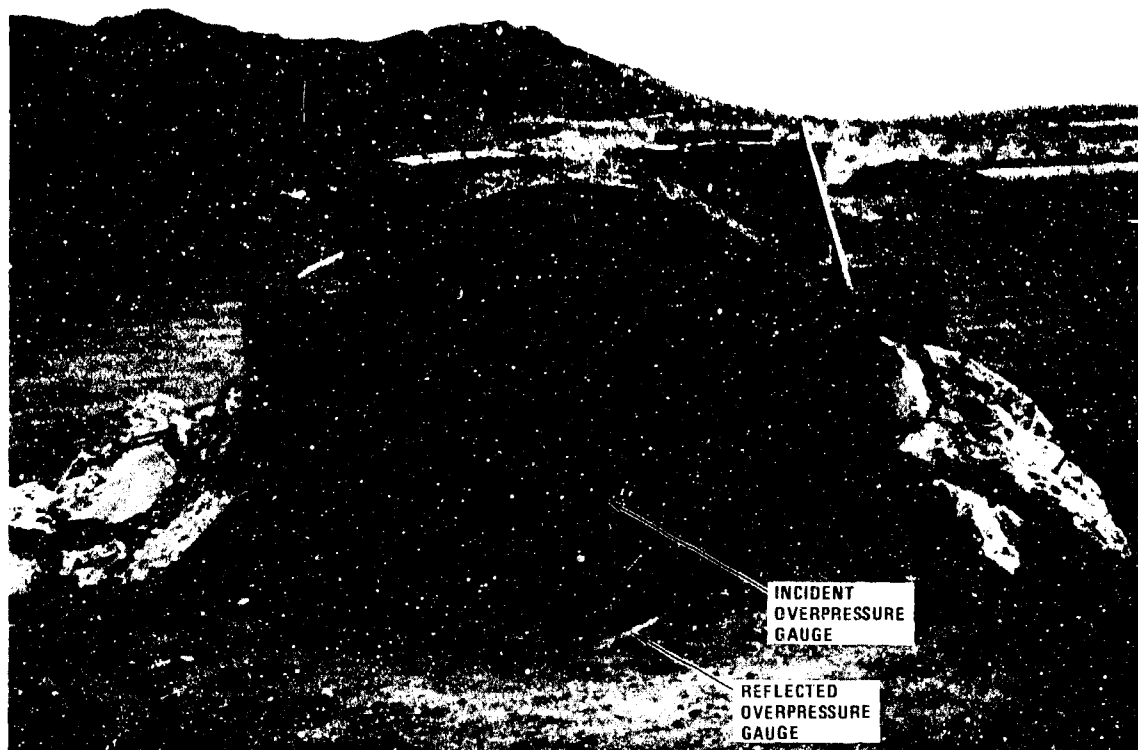
FIGURE 17. Far-Field Blast-Gauge Fixture.

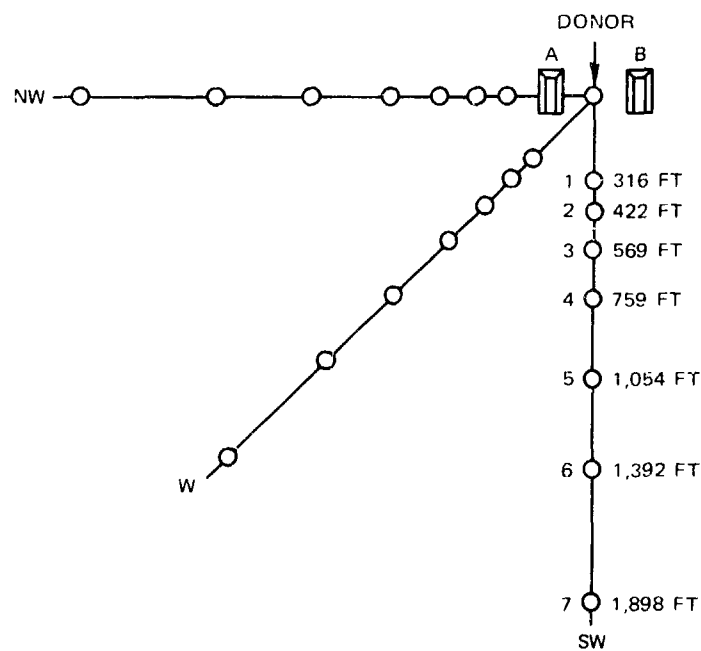
FIGURE 18. BRL, Self-Recording, Blast-Gauge Layout.

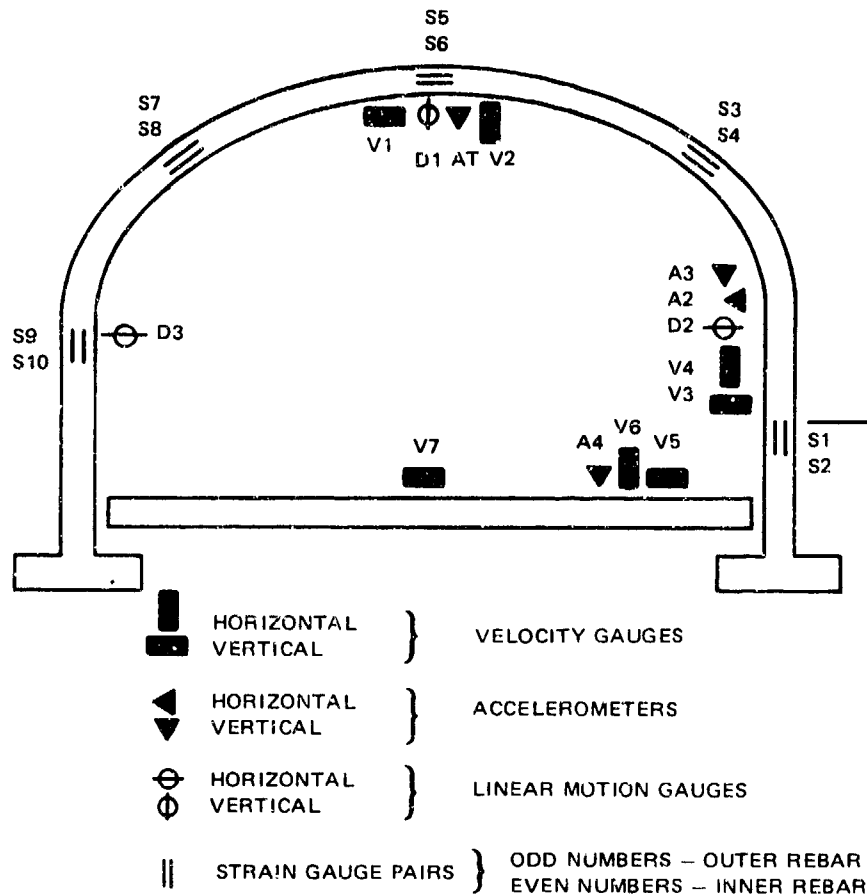
ADDITIONAL GAUGE PAIRS S11,S12, AND S13,S14 CORRESPONDING TO S5,S6 WERE LOCATED 20 FT AND 2 FT RESPECTIVELY FROM THE HEADWALL

FIGURE 19. Motion Instrumentation Installed in FRELOC Igloo.

Electronic strain gauges were attached to the steel reinforcing bar of the FRELOC magazine at several locations (see Figures 19 and 21). Several of the gauges failed to operate properly, and data on others were of questionable value. A possible reason for this may have been damage incurred during the concrete pour. A summary of strain-gauge data appears in Table 7. Figures 47 through 48 provide graphic displays of that data.

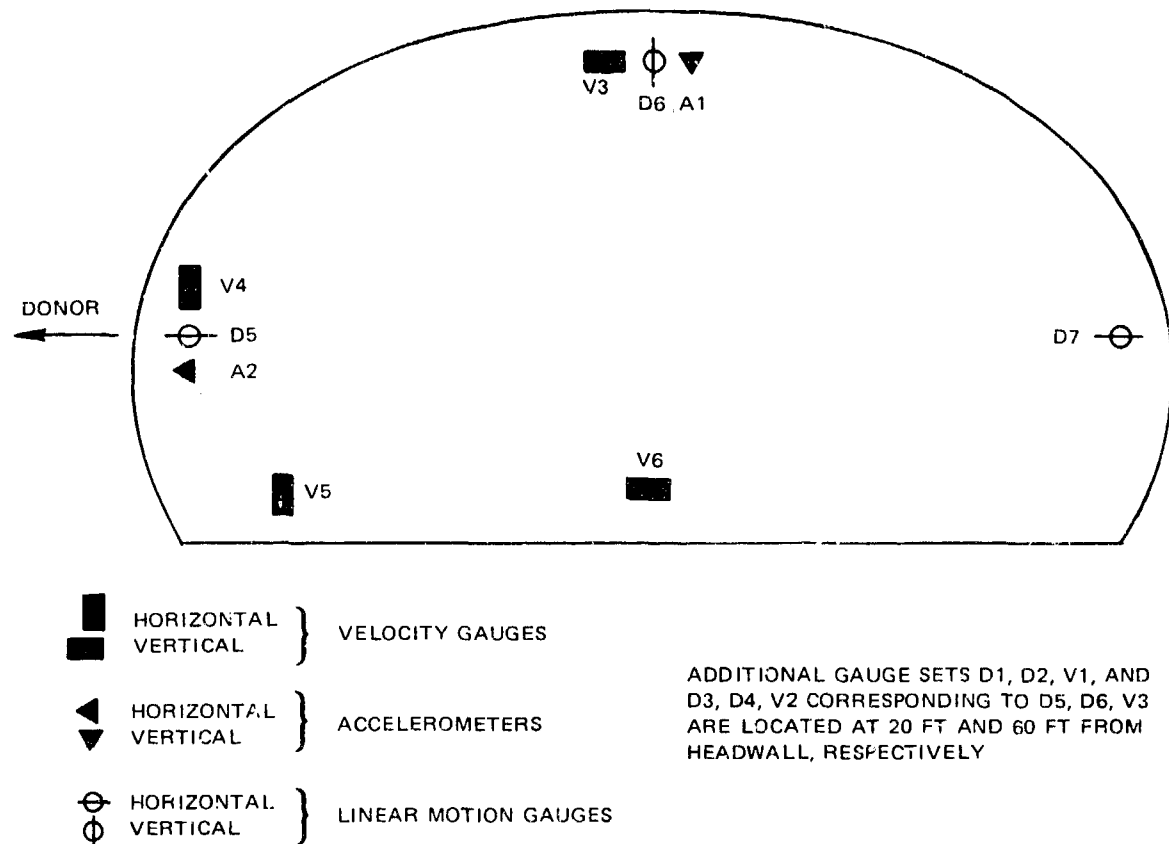
FIGURE 20. Motion Instrumentation Installed in Oval Steel-Arch Igloo.

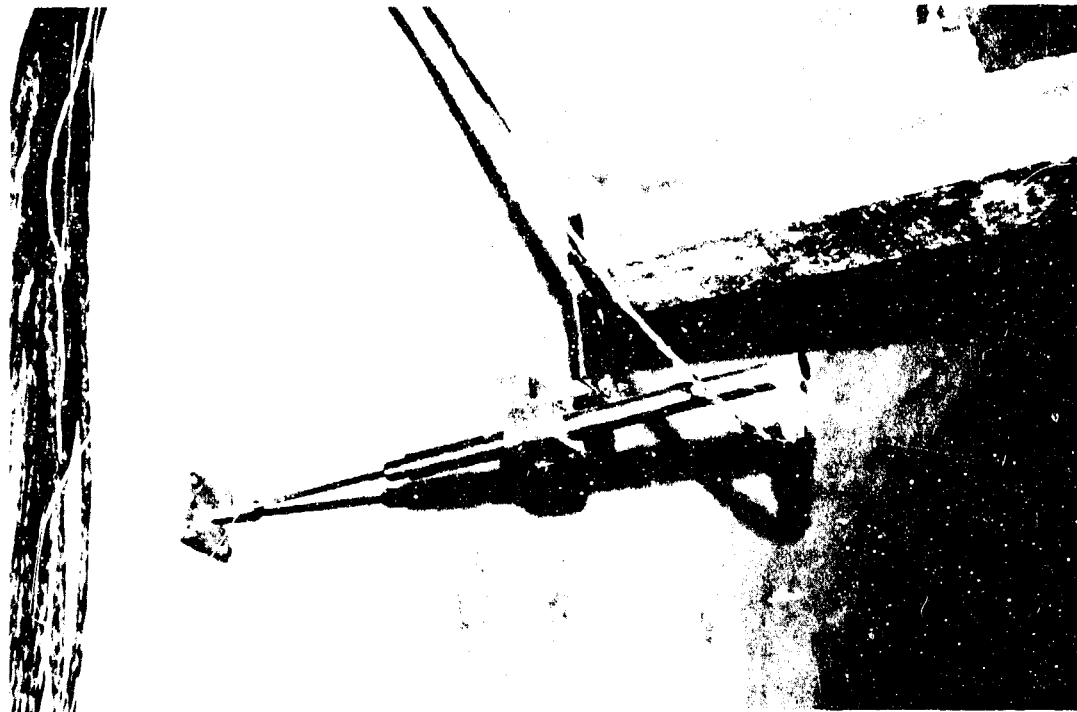
FIGURE 22. Horizontal Linear-Motion Gauge Installation, FRFLOC Igloo.

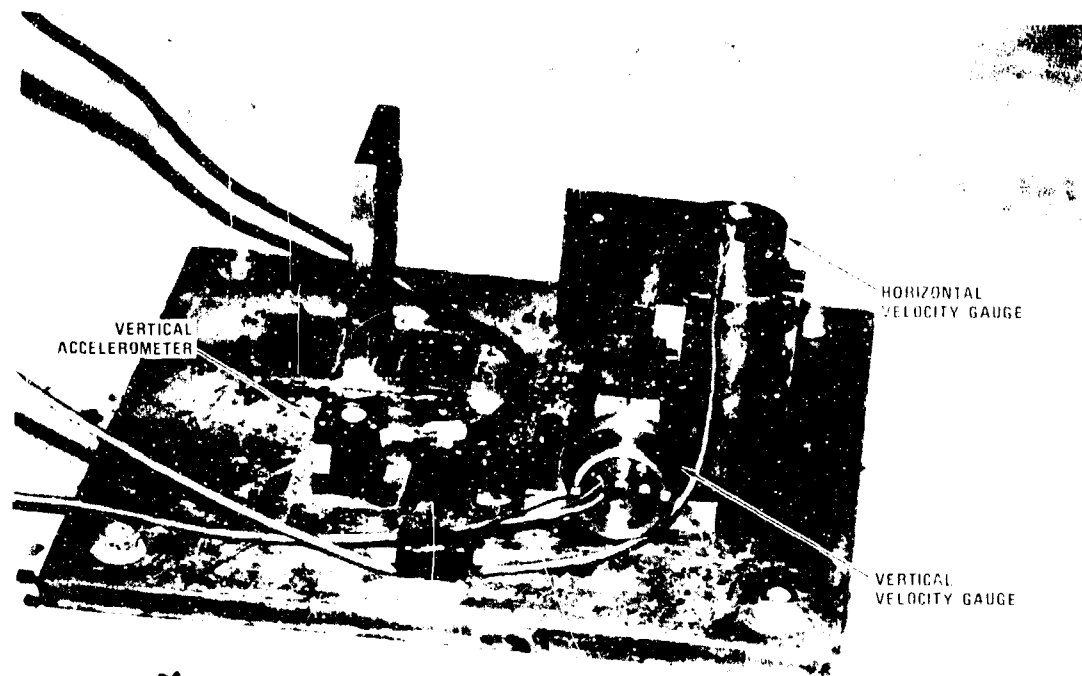
FIGURE 24. Velocity Gauge and Accelerometer Installation.

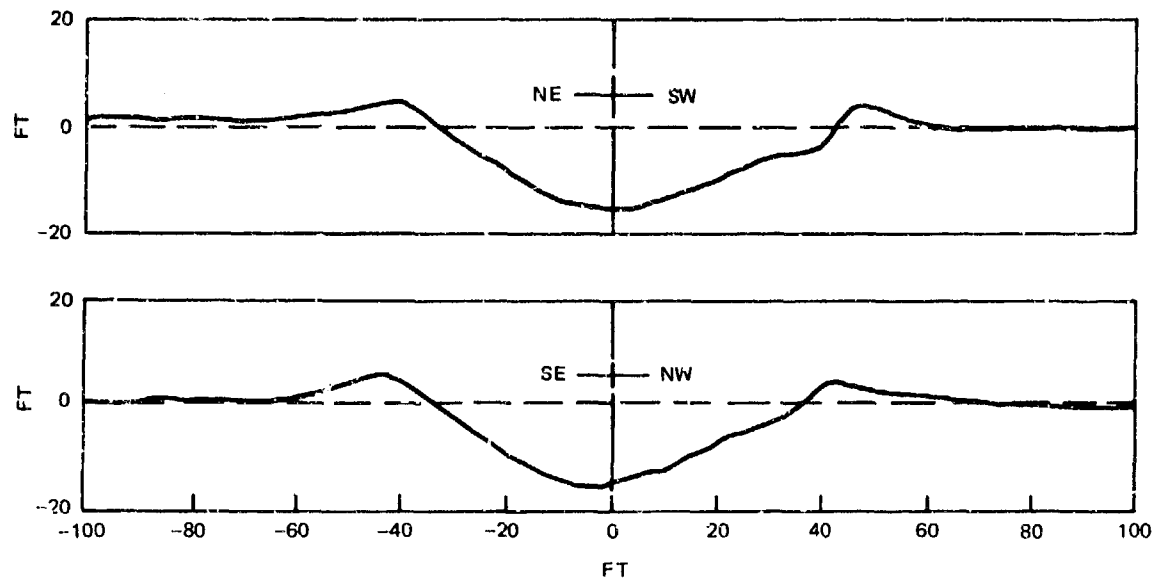
0 REPRESENTS ORIGINAL PRETEST POSITION
OF THE DONOR STACK CENTER

FIGURE 32. Donor Contours.

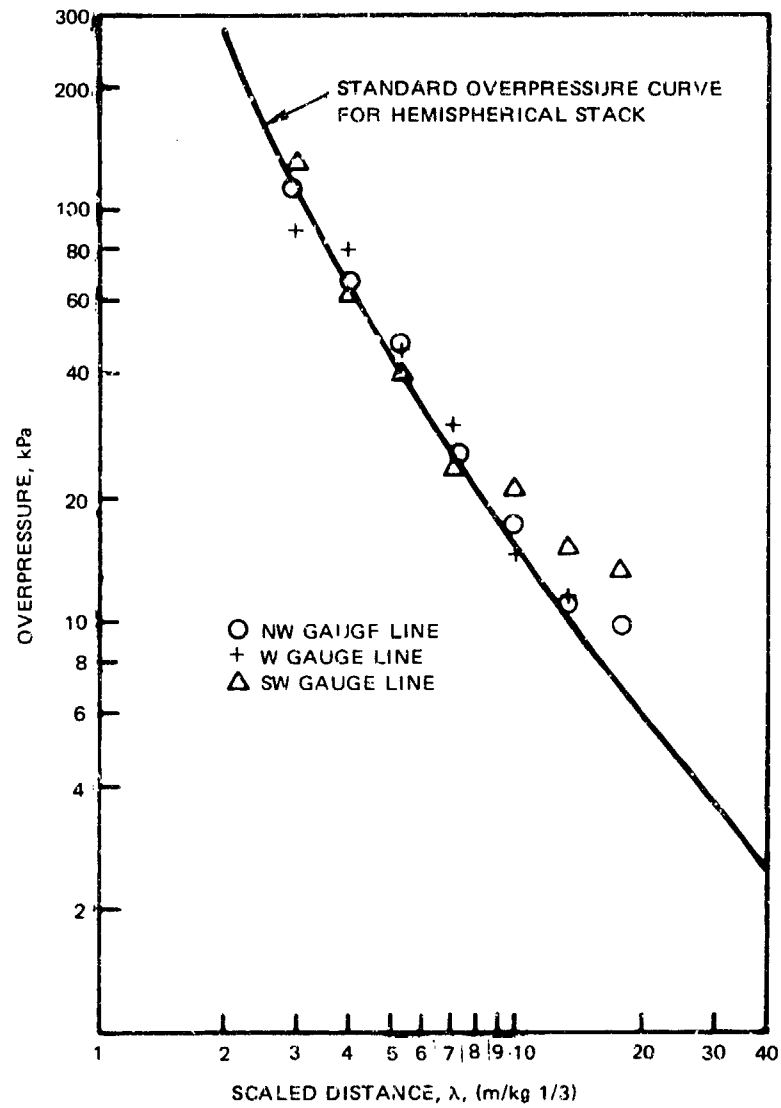
FIGURE 33. Plot of Far-Field Overpressure Recorded by BRL Gauges, Versus Scaled Distance.

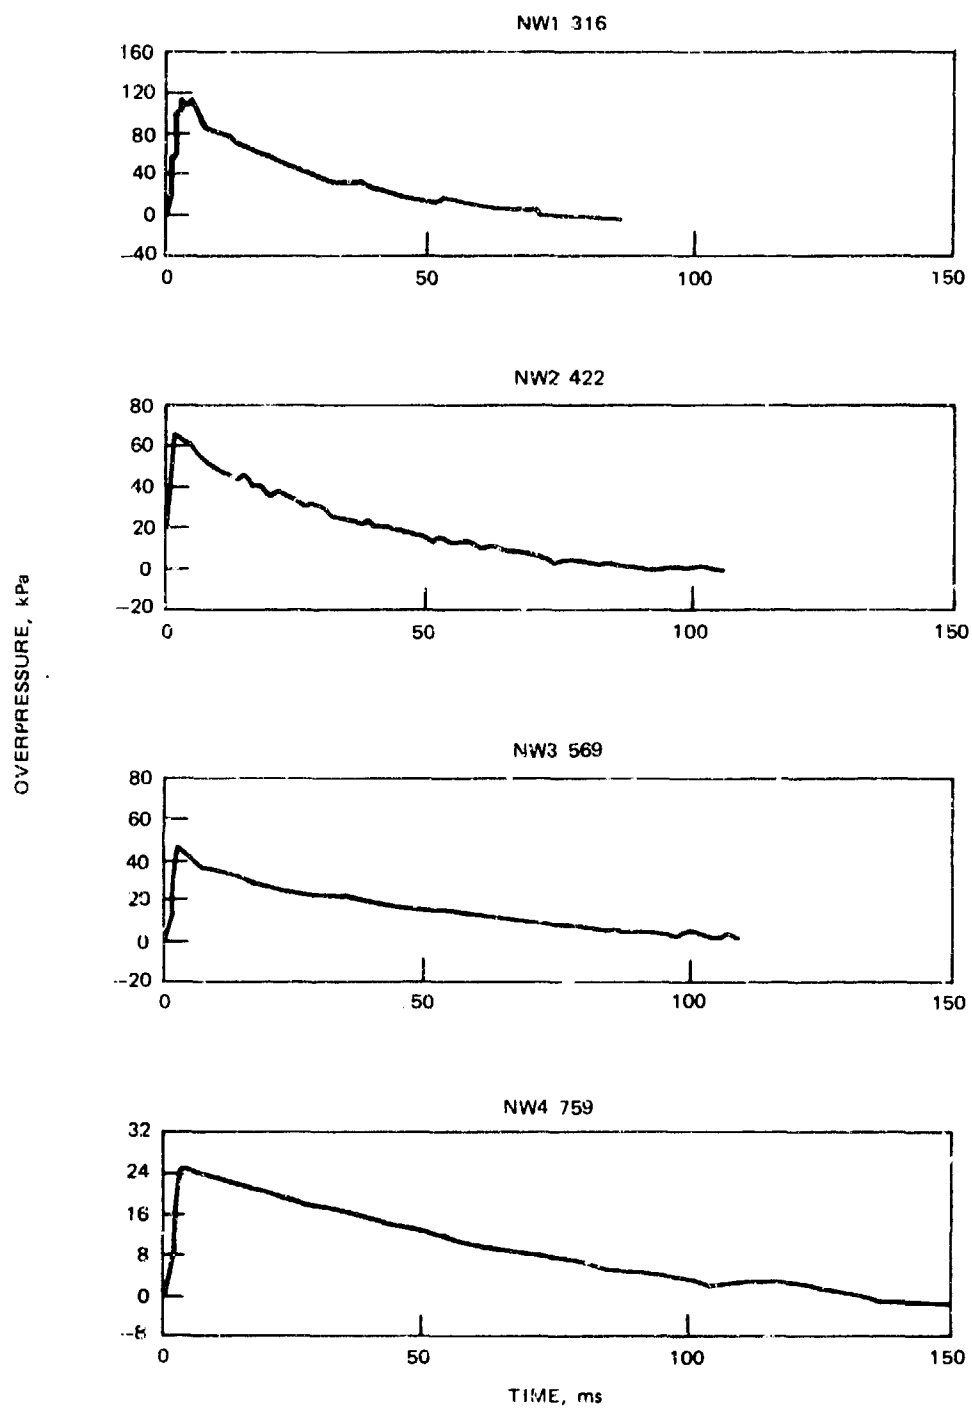
FIGURE 34. Data Plots for Far-Field Blast Gauges NW1 Through NW4.

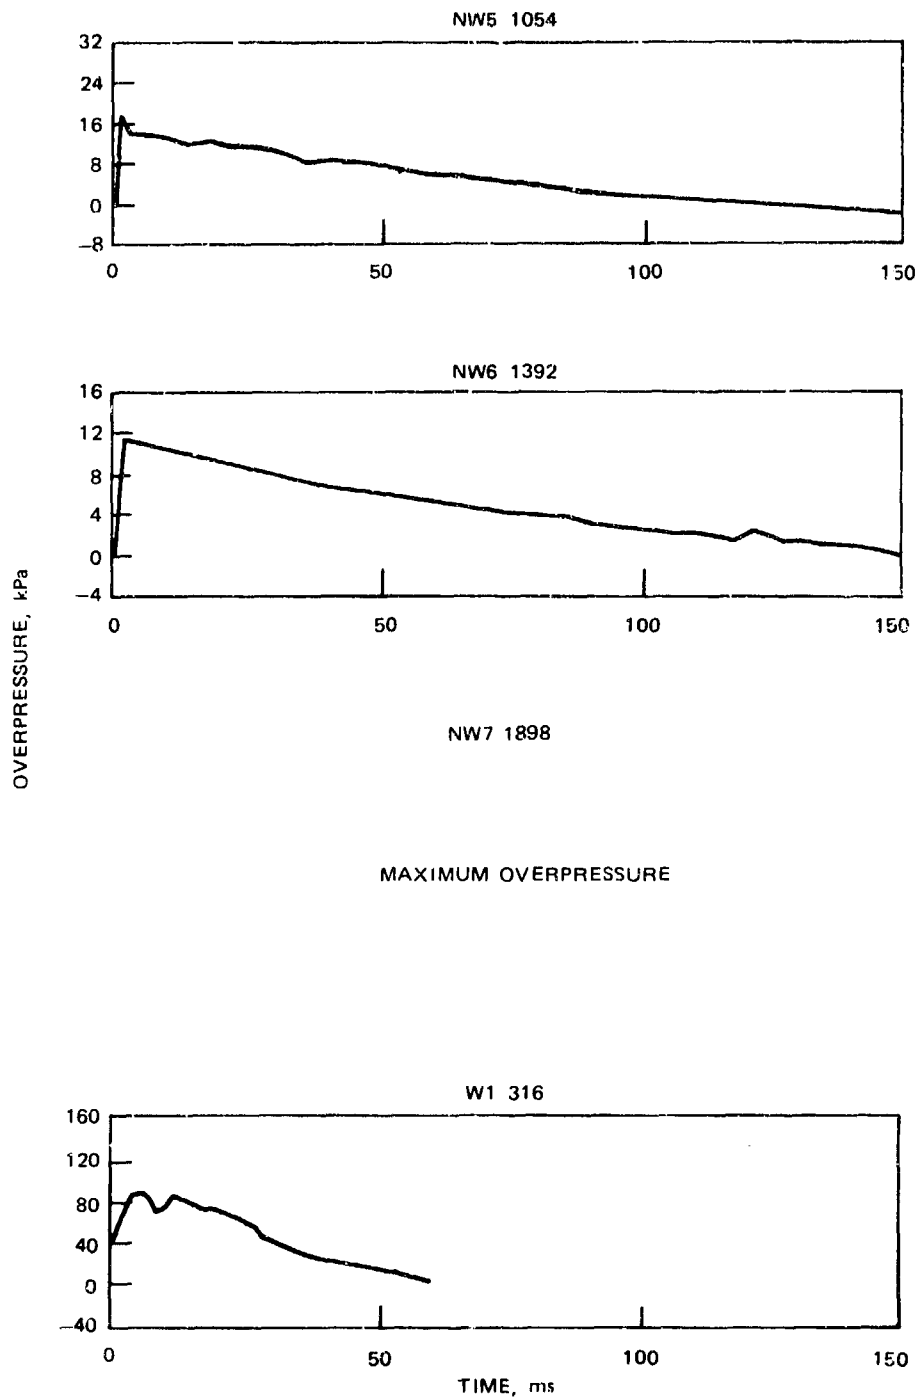
FIGURE 35. Data Plots for Far-Field Blast Gauges NW5, NW6, and W1.

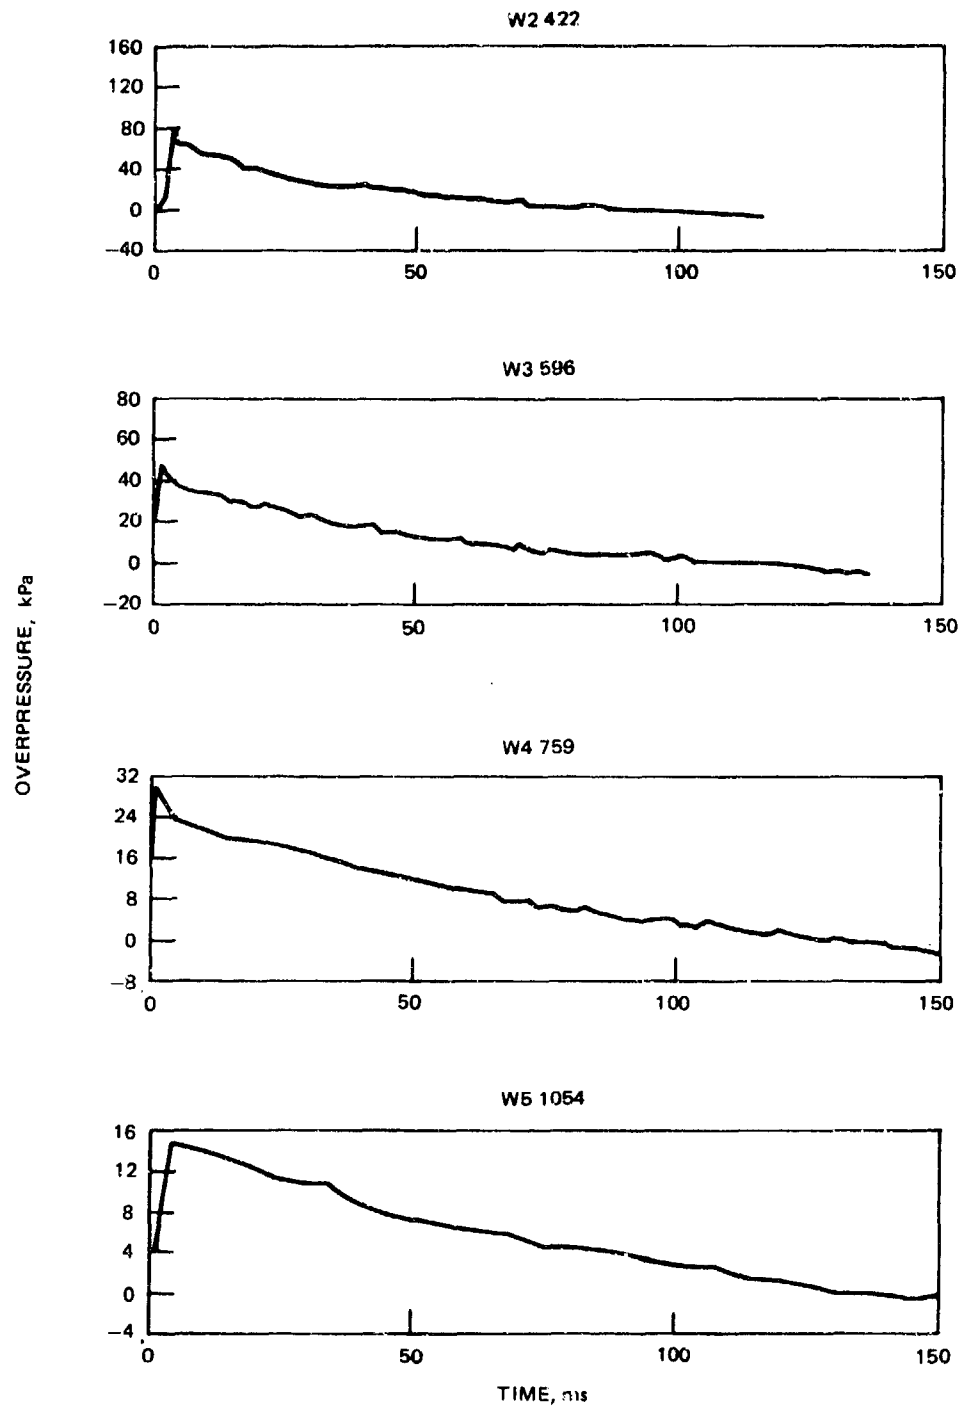
FIGURE 36. Data Plots for Far-Field Blast Gauges W2 Through W5.

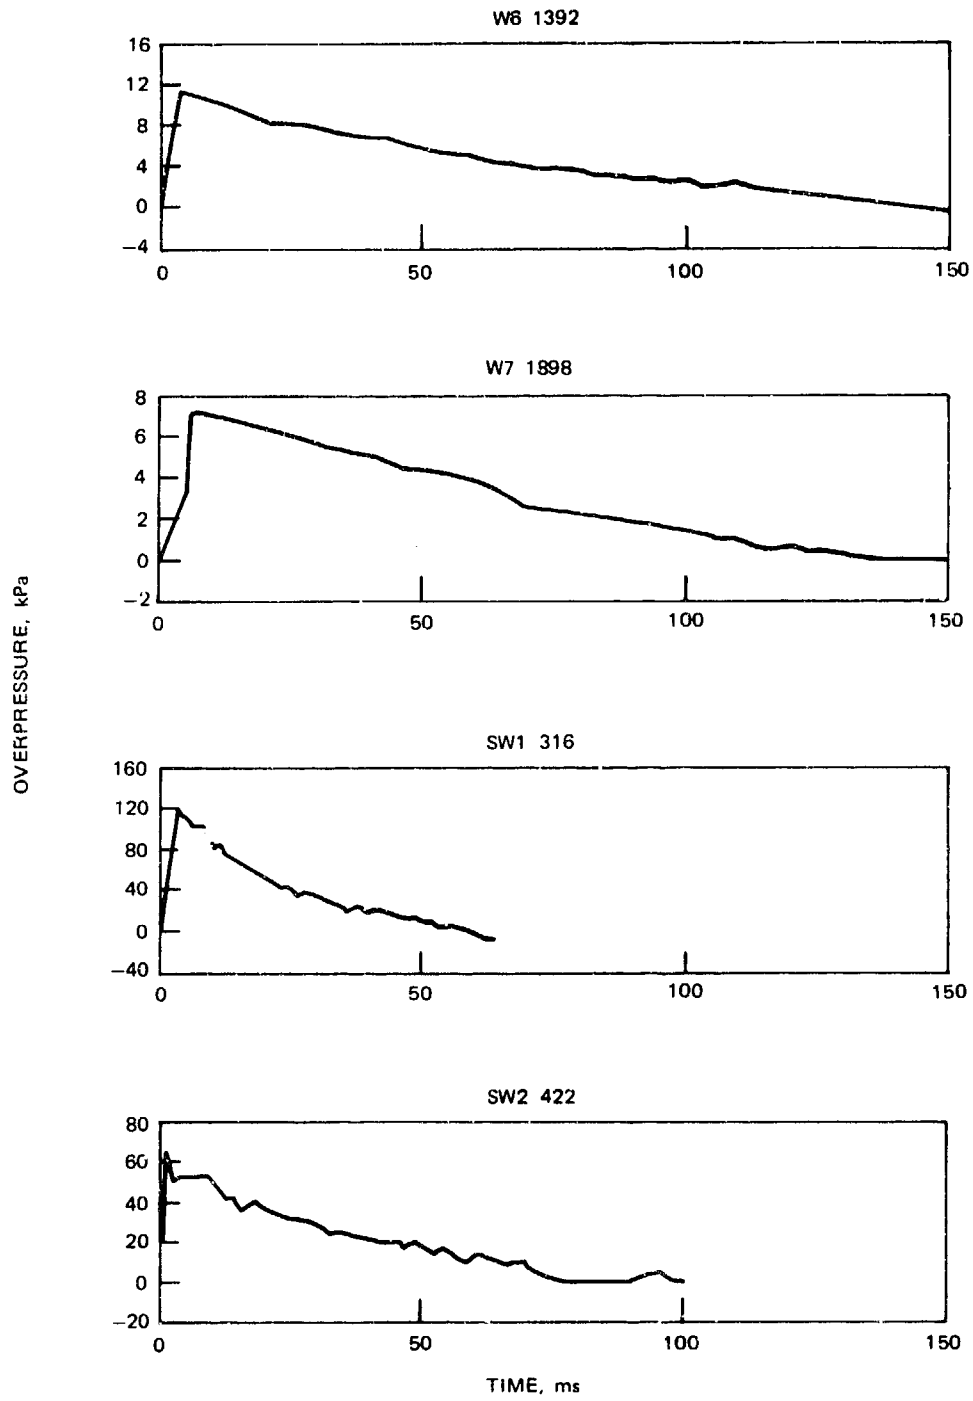
FIGURE 37. Data Plots for Far-Field Blast Gauges W6, W7, SW1, and SW2.

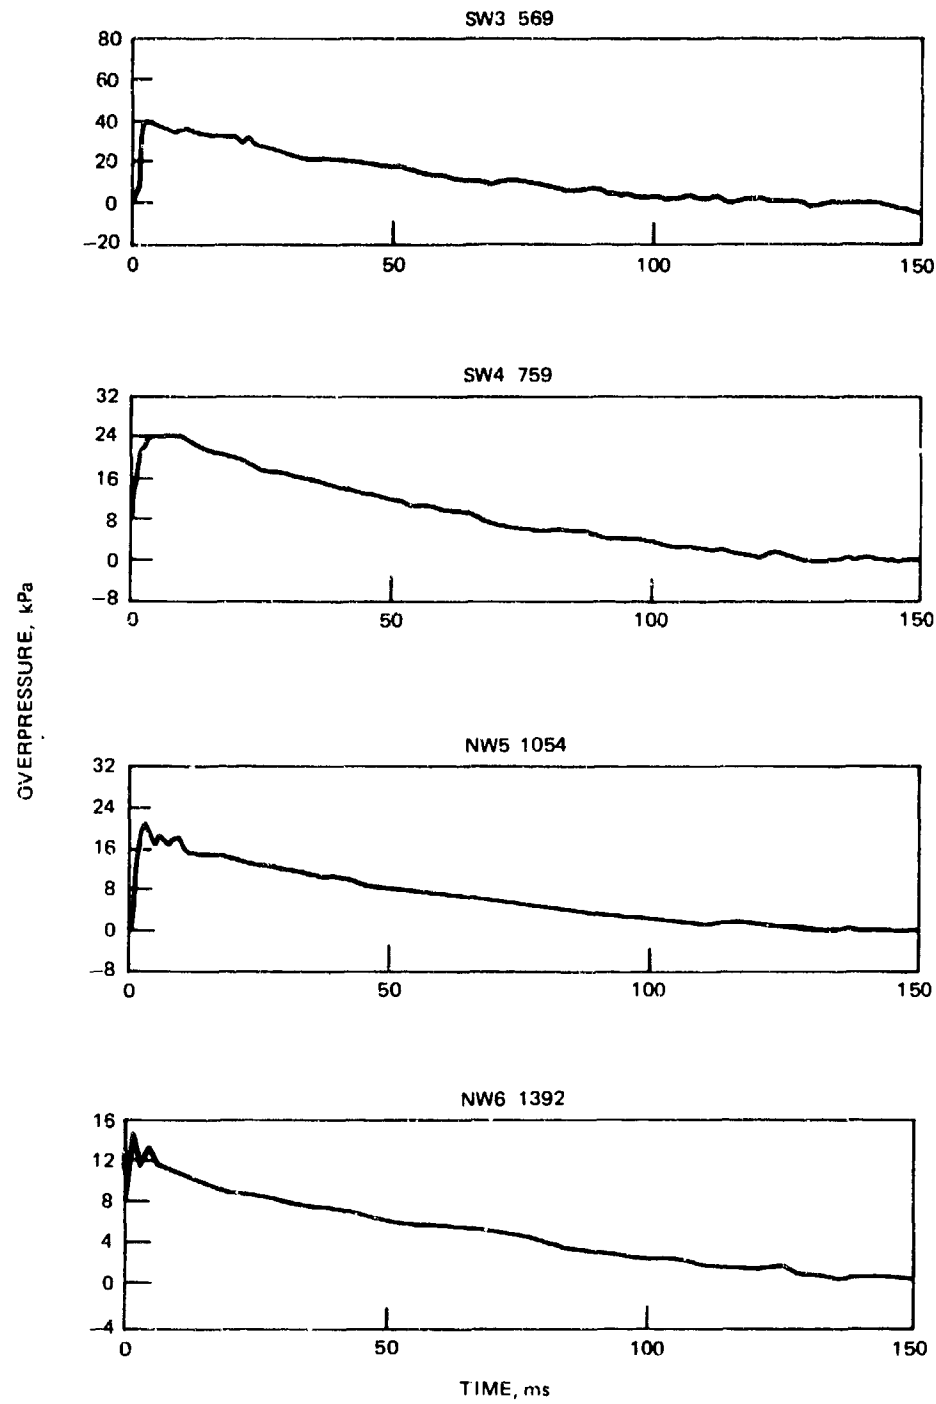
FIGURE 38. Data Plots for Far-Field Blast Gauges SW3, Through SW6.

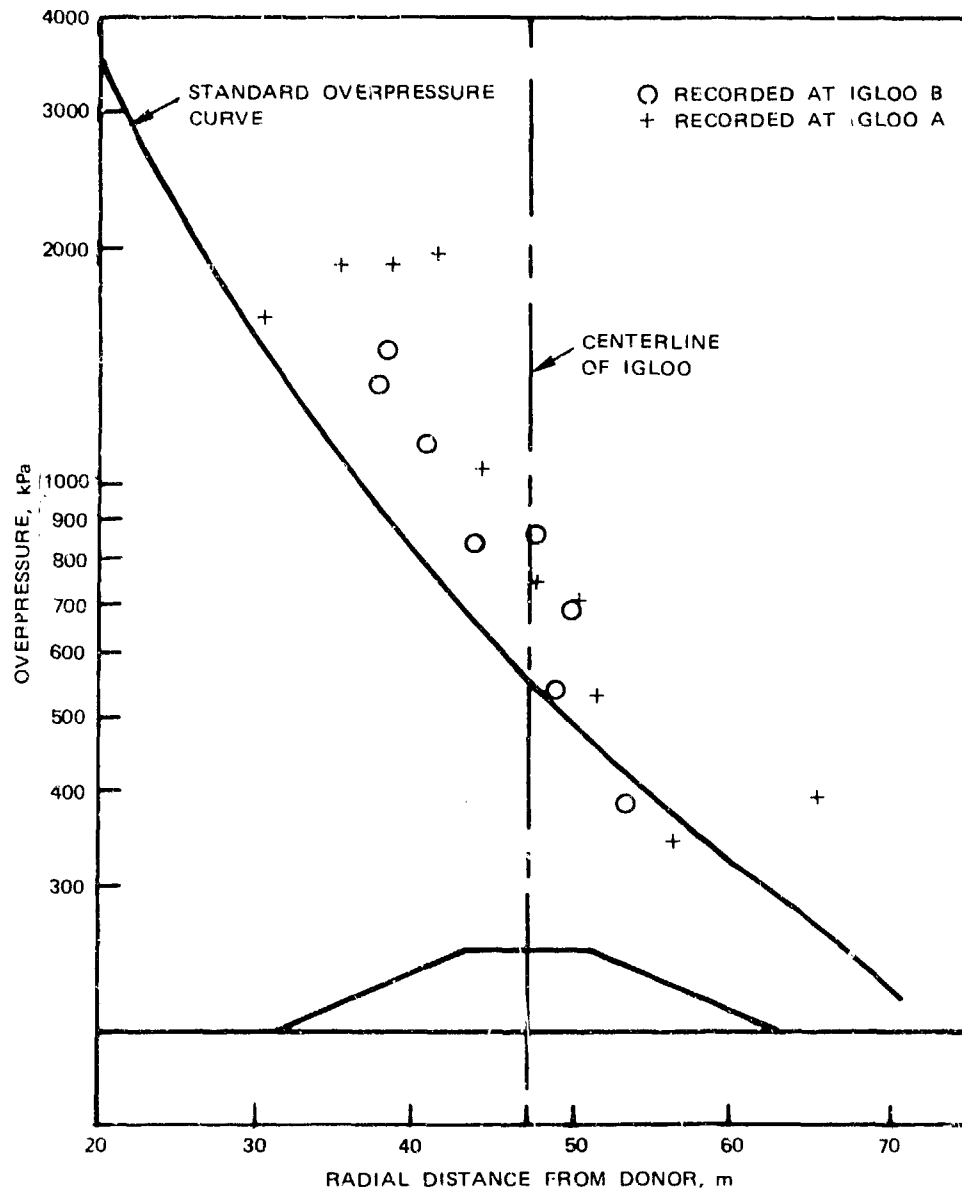
FIGURE 39. Plot of Near-Field Overpressure Recorded by Electronic Gauges, Compared With Derived Standard Curve for Hemispherical Stacks. (BRL Report 1344, September 1966.)

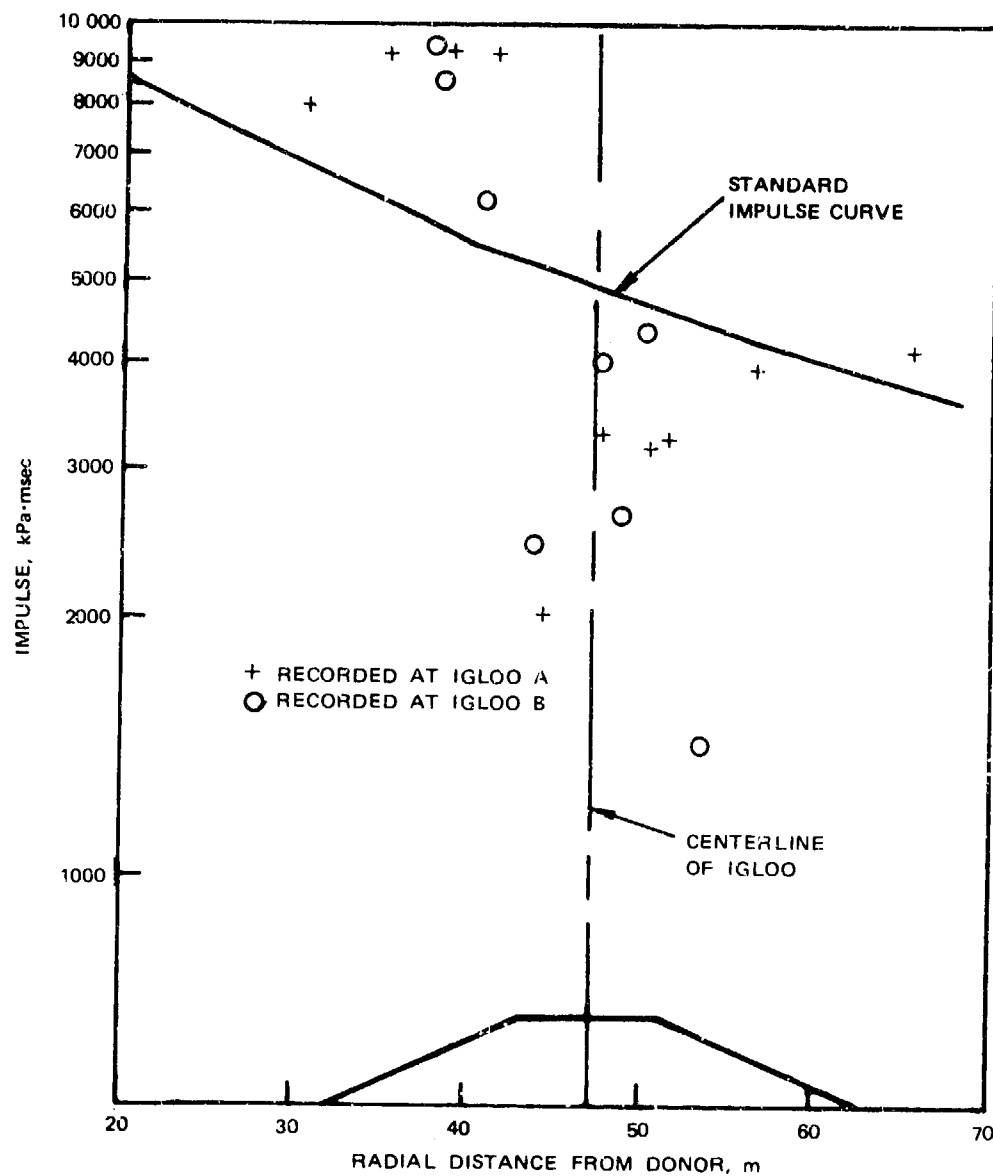
FIGURE 40. Plot of Near-Field Impulse Versus Distance, Compared With Derived Standard Curve for Hemispherical Stacks. (BRL Report 1344, September 1966.)
